**Flood Control Project Maintenance
Levee Inspections**

Fall 2019 Levee Maintenance Deficiency Summary Report

Sacramento River Basin

NA0003	Overall LMA Rating	Total LMA Miles						
Butte County Department of Public Works	A	23.78						
Rated Item	Maintenance Deficiency				Enforcement		Design & System Obsolescence	
	M Miles	U Miles	M + 4U Miles	Threshold %	M Miles	U Miles	M Miles	U Miles
<i>Earthen Levee</i>								
Vegetation	0.35		0.35	1.47%	0.03	0.23		
Trim / Thin Trees	0.15		0.15	0.63%				
Encroachments	0.03		0.03	0.13%	2.61	0.48		
Animal Control	0.03		0.03	0.13%				
Slope Stability	0.10		0.10	0.42%				
Erosion / Bank Caving	0.01		0.01	0.04%				
<i>Supplemental</i>								
DRAFT DWR UCIP Field Study					0.10			
DRAFT DWR UCIP LMA Responsibility								
<i>LMA Totals:</i>	0.67	0.00	0.67	2.82%	2.74	0.71	0.00	0.00

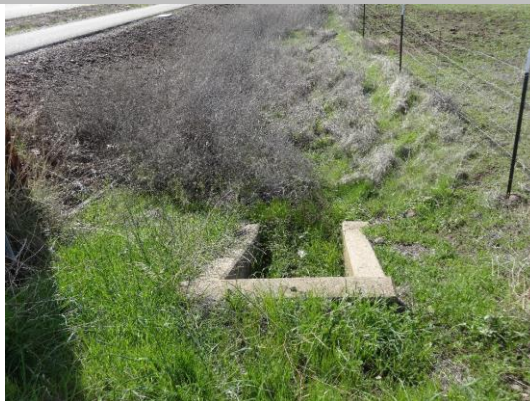
Photo 2 of 3 : UCIP_FA_2019_32124_58624.jpg

LS view: U type concrete headwall of CMP culvert on levee slope.
Vegetation on inlet box.

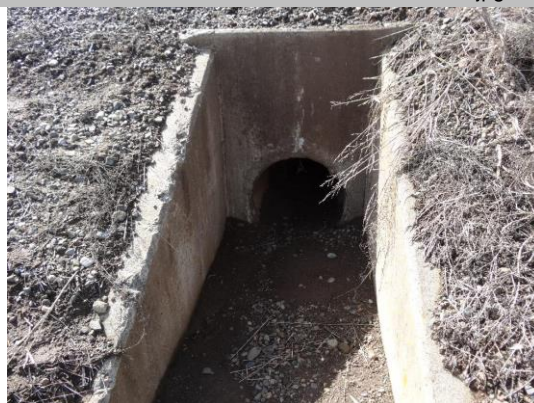
Photo 2 of 3 : UCIP_FA_2019_31901_58193.jpg

LS view: U type concrete headwall and CMP on levee slope. Soil/mud on inlet box.

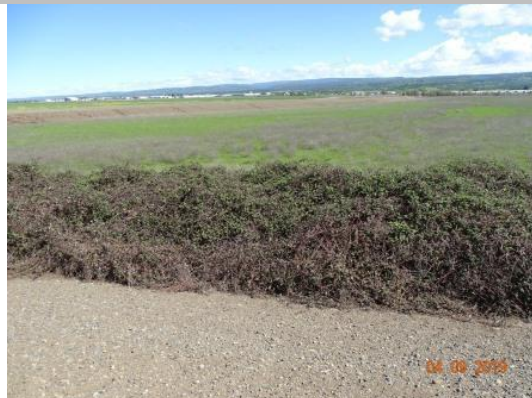
Photo 1 of 1 : FA_2019_NA0003_67_22_20190822_00005.jpg

LM Start	3.09	Rating **	M	Issue No.	22
LM End	3.09	Issue Type +	Ma	Location *	LS
Category	Earthen Levee			GPS Latitude/Longitude	
				Start	End
Item	Vegetation			39.777880 °	39.777880 °
				-121.854230 °	-121.854230 °
DWR ID	DWR_NA0003_03_s_2019_22				
Comment Code					
V2 : Remove the wild growth other than native grasses from the levee slopes.					
Inspector Comment

View of the wild growth at the landside toe. Spring 2019.

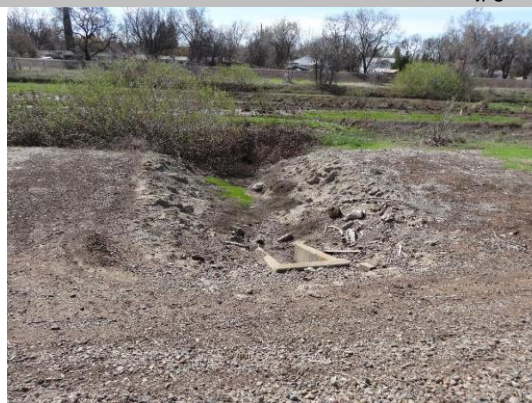
Photo 1 of 3 : UCIP_FA_2019_31902_58201.jpg

WS view: U type concrete headwall and grouted riprap spillway on levee slope.

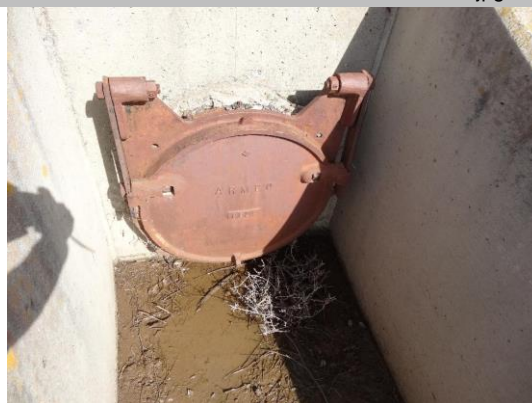
Photo 2 of 3 : UCIP_FA_2019_31902_58200.jpg

WS view: U type concrete headwall and CMP on levee slope.

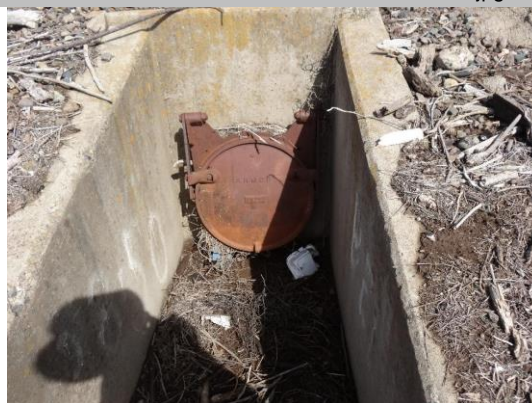
Photo 1 of 3 : UCIP_FA_2019_31864_58069.jpg

WS view: U type concrete headwall, pipe, and flapgate on levee slope. Soil/mud on outlet box. Vegetation debris blocking outlet box.

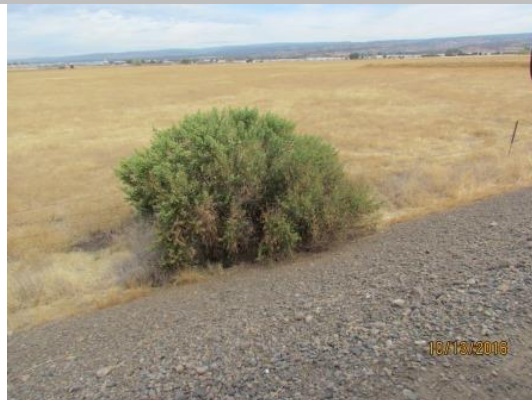
Photo 1 of 1 : FA_2019_NA0003_67_14_20190822_00003.jpg

LM Start	3.38	Rating **	M	Issue No.	14
LM End	3.38	Issue Type +	Ma	Location *	LS
Category	Earthen Levee			GPS Latitude/Longitude	
				Start	End
Item	Vegetation			39.777429 °	39.777429 °
				-121.848937 °	-121.848937 °
DWR ID	DWR_NA0003_03_f_2016_14				
Comment Code					
V2 : Remove the wild growth other than native grasses from the levee slopes.					
Inspector Comment

View of a bush along the landside toe.

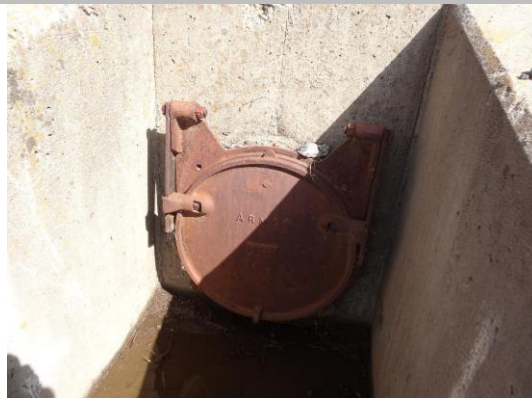
Photo 1 of 3 : UCIP_FA_2019_31856_58053.jpg

WS view: U type concrete headwall, pipe, and flapgate on levee slope. Soil/mud on outlet box.

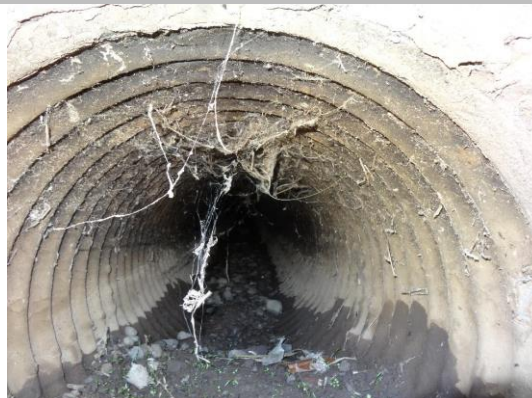
Photo 3 of 3 : UCIP_FA_2019_31856_58051.jpg

LS view: inside view of CMP on levee slope. Needs cleaning and clearing.

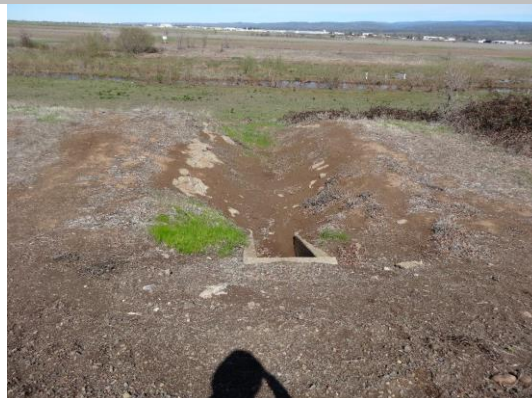
Photo 1 of 3 : UCIP_FA_2019_32026_58520.jpg

WS view: concrete headwall and grouted riprap spillway on levee slope.

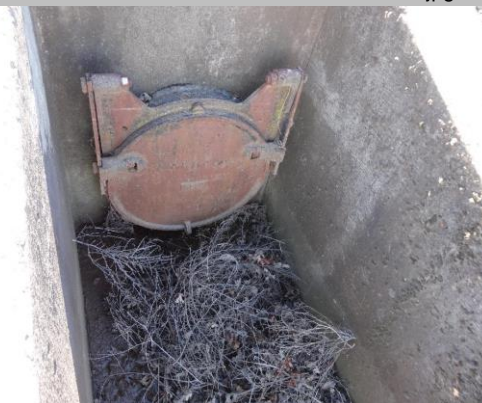
Photo 2 of 3 : UCIP_FA_2019_32026_58519.jpg

WS view: U type concrete headwall and CMP on levee slope. Mud and vegetation debris on outlet box.

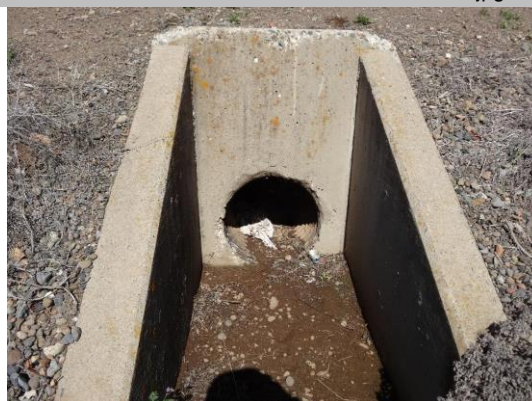
Photo 3 of 3 : UCIP_FA_2019_32026_58518.jpg

LS view: U type concrete headwall and CMP on levee slope. Mud and pebbles on inlet box.

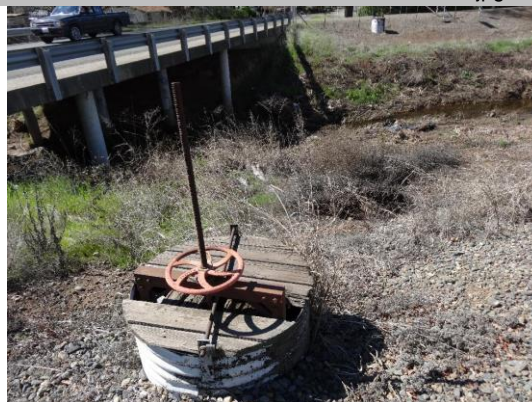
Photo 1 of 3 : UCIP_FA_2019_32025_58512.jpg

WS view: slide gate in CMP riser on waterside shoulder.

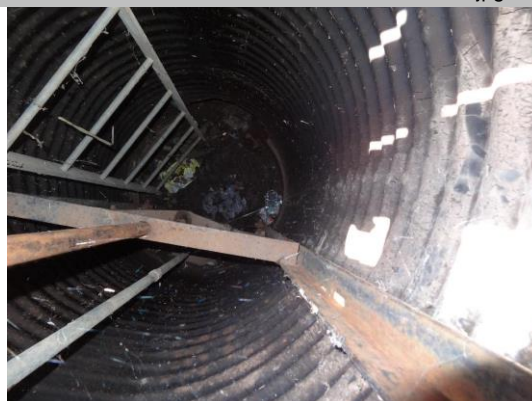
Photo 2 of 3 : UCIP_FA_2019_32025_58511.jpg

Comment Code						
Inspector Comment						
DS_ID:19280 FS_ID:32025 EP_NO: N/A Repair Type: Non-Urgent Crossing Status: Found UCIP Comments: Slide gate in a CMP riser. Vegetation debris and mud on inlet box.Needs cleaning and clearing the culvert. FIELD_STRUCT_DESC: 24-inch corrugated metal gravity drainage pipe through the levee and under the channel, 9.5 feet below the crown. Slide gate in a corrugated metal pipe (CMP) riser on the waterside (WS) slope. Concrete U-shaped headwall on the landside (LS) end. [Additional Reference(s): DWR Levee Log, 1992. USACE Sacramento O&M Manual 504, May 1965, (HLM 0.34)]. FS Date: 3/7/2014

WS view: inside view of slide gate in CMP riser on waterside shoulder. Debris trapped in the riser.

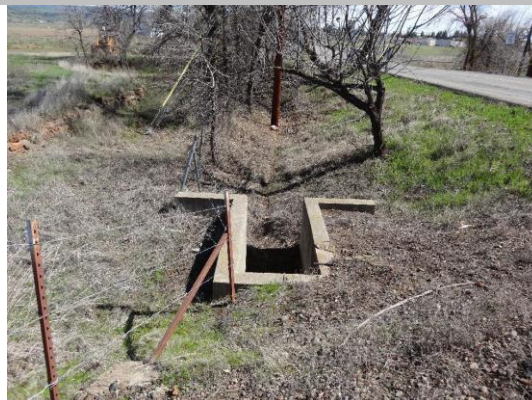
Photo 3 of 3 : UCIP_FA_2019_32025_58510.jpg

LS view: U type concrete headwall and CMP on levee slope. Vegetation debris and mud on inlet box.

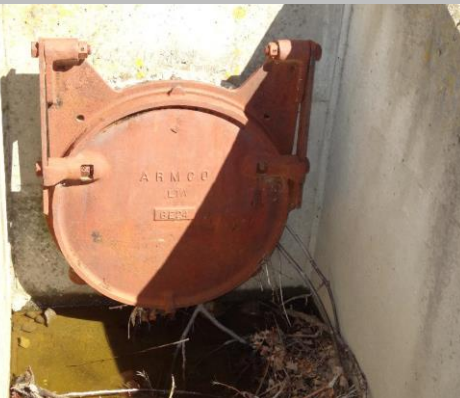
Photo 1 of 3 : UCIP_FA_2019_32023_58505.jpg

WS view: U type concrete headwall and CMP on levee slope. Vegetation debris and mud on outlet box. Needs cleaning and clearing.

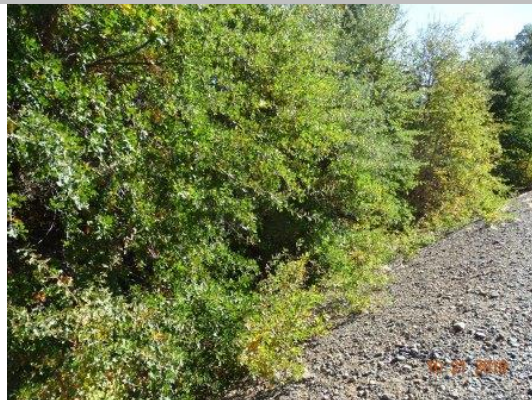
Photo 1 of 1 : FA_2019_NA0003_68_14_20191028_00035.jpg

LM Start	0.35	Rating **	M	Issue No.	14
LM End	0.38	Issue Type +	Ma	Location *	WS
Category	Earthen Levee			GPS Latitude/Longitude	
				Start	End
Item	Trim / Thin Trees			39.775656°	39.775289°
				-121.850308°	-121.849907°
DWR ID	DWR_NA0003_04_f_2019_14				
Comment Code					
T1 : Trim trees to at least five feet above ground level.					
Inspector Comment

View of trees and wild growth along the waterside slope and toe. Fall 2019.

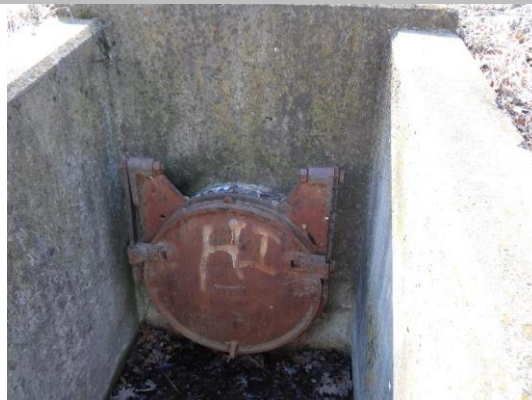
Photo 1 of 2 : UCIP_FA_2019_32143_58641.jpg

LM Start	0.92	Rating **	M	Issue No.	45
LM End	0.92	Issue Type +	Ma	Location *	
Category	Supplemental			GPS Latitude/Longitude	
				Start	End
Item	DRAFT DWR UCIP LMA Responsibility			39.775704 °	39.775704 °
				-121.850901 °	-121.850901 °
DWR ID	19287				
Comment Code					
Inspector Comment					
DS_ID:19287 FS_ID:32143 EP_NO: N/A Repair Type: Non-Urgent Crossing Status: Found UCIP Comments: Needs cleaning and clearing the culvert. FIELD_STRUCT_DESC: 24-inch corrugated metal gravity drainage pipe through the levee, 9 feet below the crown. Flap gate on the waterside (WS) end. Concrete U-shaped headwall on each end. Grouted riprap apron on the landside (LS) end. Grouted riprap spillway on the WS end. [Additional Reference(s): DWR Levee Log, 1992. USACE Sacramento O&M Manual 504, May 1965, (HLM 0.96)]. FS Date: 3/7/2014

WS view: U type concrete headwall and CMP on levee slope. Soil/mud on outlet box. Needs cleaning and clearing.

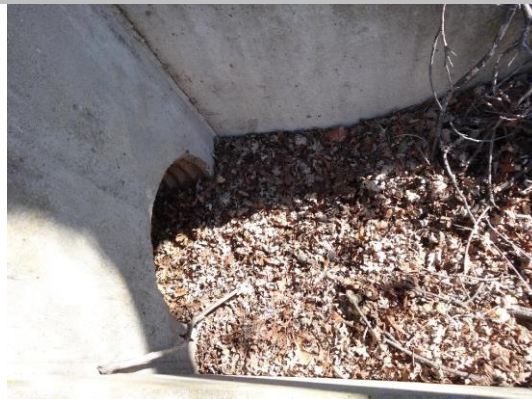
Photo 2 of 2 : UCIP_FA_2019_32143_58640.jpg

LS view: U type concrete headwall and CMP on levee slope. Vegetation and mud on inlet box.

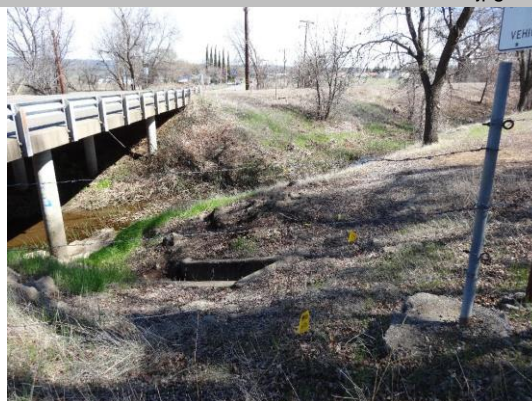
Photo 1 of 2 : UCIP_FA_2019_31946_58357.jpg

LM Start	0.92	Rating **	M	Issue No.	46
LM End	0.92	Issue Type +	En	Location *	
Category	Supplemental			GPS Latitude/Longitude	
				Start	End
Item	DRAFT DWR UCIP Field Study			39.775729 °	39.775729 °
				-121.850950 °	-121.850950 °
DWR ID	19293				
Comment Code					
Inspector Comment					
DS_ID:19293 FS_ID:31946 EP_NO: 15950 Repair Type: Non-Urgent Crossing Status: Indicator Found UCIP Comments: Only little gasoline indicator flags found on both sides of the levee and across the creek. FIELD_STRUCT_DESC: 6-inch high-pressure natural gas main line of an unknown material through both levees and under Dry Creek, 2 feet below the crown. (Plans to place a 6-inch high-pressure gas main under both levees and creek bed to a depth of 5 feet across Dry Creek authorized under Permit No. 15950, 1992 - Pacific Gas and Electric Company [PG&E]). FS Date: 3/7/2014

WS view: little gasoline indicator (yellow flags) on both sides of the levee.

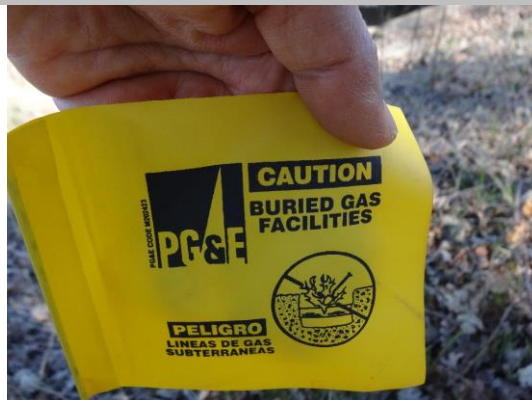
Photo 2 of 2 : UCIP_FA_2019_31946_58356.jpg

WS view: close up view of little gasoline indicator.

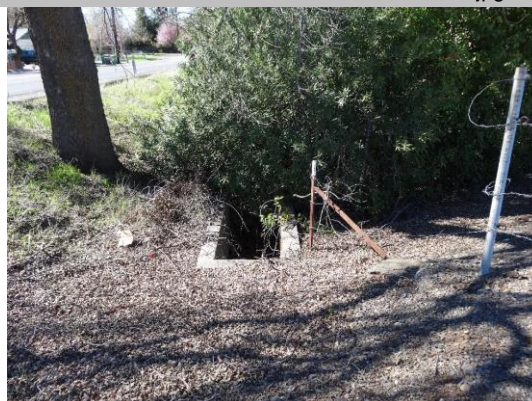
Photo 1 of 3 : UCIP_FA_2019_32144_58644.jpg

Comment Code					
Inspector Comment					
DS_ID:19288					
FS_ID:32144					
EP_NO: N/A					
Repair Type: Non-Urgent					
Crossing Status: Found					
UCIP Comments: Slide gate in CMP riser on waterside. No access to CMP riser.Needs cleaning and clearing the culvert.					
FIELD_STRUCT_DESC: 24-inch corrugated metal gravity drainage pipe through the levee and under the channel, 9.5 feet below the crown.					
Slide gate in a pipe riser on the waterside (WS) slope. Concrete U-shaped headwall on the landside (LS) end. [Additional Reference(s): DWR Levee Log, 1992. USACE Sacramento O&M Manual 504, May 1965, (HLM 0.98)].					
FS Date: 3/7/2014

LS view: U type concrete headwall of CMP culvert on levee slope. Vegetation debris and mud on inlet box.

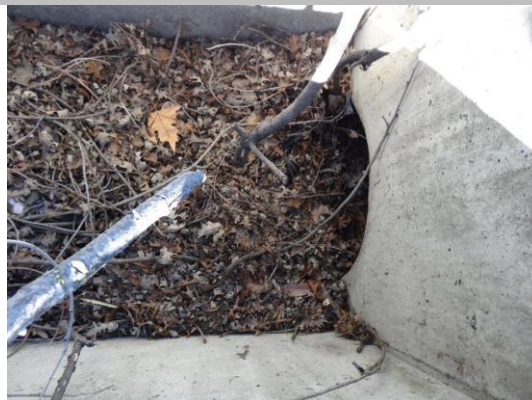
Photo 2 of 3 : UCIP_FA_2019_32144_58643.jpg

LS view: close view of vegetation debris and mud on inlet box.

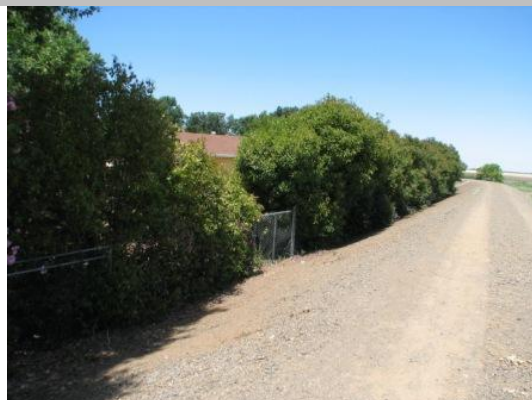
Photo 1 of 1 : FA_2019_NA0003_68_1_20190822_00001.jpg

LM Start	0.94	Rating **	M	Issue No.	1
LM End	1.01	Issue Type +	En	Location *	LS
Category	Earthen Levee			GPS Latitude/Longitude	
				Start	End
Item	Encroachments			39.776013 °	39.776595 °
				-121.851175 °	-121.852005 °
DWR ID	DWR_NA0003_04_s_2012_1				
Comment Code					
FE : Fence					
Inspector Comment

View of the fence and trees along the landside toe of the levee.

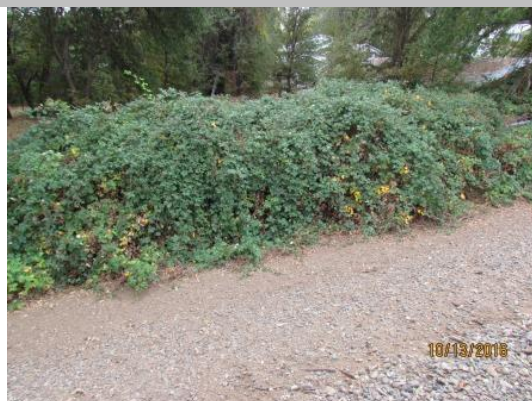
Photo 1 of 1 : FA_2019_NA0003_68_23_20190822_00007.jpg

LM Start	1.04	Rating **	M	Issue No.	23
LM End	1.04	Issue Type +	Ma	Location *	LS
Category	Earthen Levee			GPS Latitude/Longitude	
				Start	End
Item	Vegetation			39.776589 °	39.776589 °
				-121.852600 °	-121.852600 °
DWR ID	DWR_NA0003_04_f_2016_23				
Comment Code					
V2 : Remove the wild growth other than native grasses from the levee slopes.					
Inspector Comment

View of the blackberries blocking visibility and access.

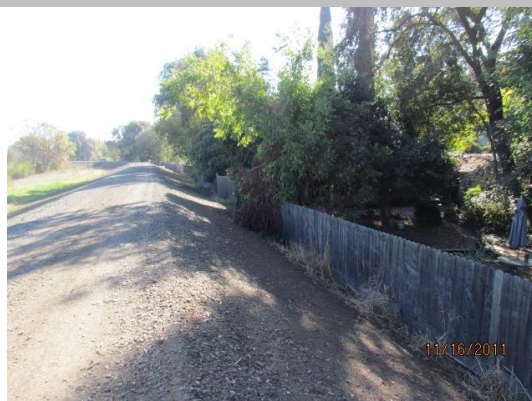
Photo 1 of 1 : FA_2019_NA0003_68_3_20190822_00003.jpg

LM Start	1.11	Rating **	U	Issue No.	3
LM End	1.22	Issue Type +	En	Location *	LS
Category	Earthen Levee			GPS Latitude/Longitude	
				Start	End
Item	Encroachments			39.77760°	39.777650°
				-121.854022°	-121.855687°
DWR ID	DWR_NA0003_04_s_2012_3				
Comment Code					
FE : Fence					
Inspector Comment

View of the fence along the landside toe.

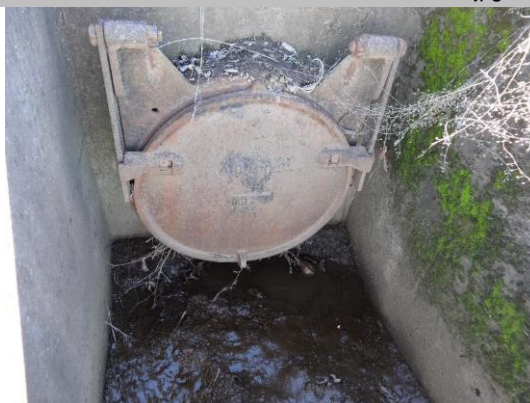
Photo 1 of 2 : UCIP_FA_2019_31964_58389.jpg

LM Start	1.35	Rating **	M	Issue No.	49
LM End	1.35	Issue Type +	Ma	Location *	
Category	Supplemental			GPS Latitude/Longitude	
				Start	End
Item	DRAFT DWR UCIP LMA Responsibility			39.778370 °	39.778370 °
				-121.857904 °	-121.857904 °
DWR ID	19290				
Comment Code					
Inspector Comment					
DS_ID:19290 FS_ID:31964 EP_NO: N/A Repair Type: Non-Urgent Crossing Status: Found UCIP Comments: Needs cleaning and clearing the culvert. FIELD_STRUCT_DESC: 24-inch corrugated metal gravity drainage pipe through the levee, 13 feet below the crown. Flap gate on the waterside (WS) end. Concrete U-shaped headwall on each end. Grouted riprap apron on the landside (LS) end. Grouted riprap spillway on the WS end. [Additional Reference(s): DWR Levee Log, 1992. USACE Sacramento O&M Manual 504, May 1965, (HLM 1.41)]. FS Date: 3/7/2014

WS view: U type concrete headwall and CMP on levee slope. Vegetation debris and mud in outlet box. Needs cleaning and clearing.

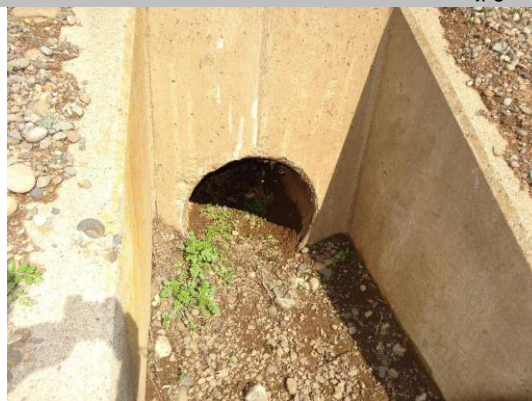
Photo 2 of 3 : UCIP_FA_2019_31965_58394.jpg

LM Start	2.15	Rating **	M	Issue No.	50 (cont)	
LM End	2.15	Issue Type +	Ma	Location *		
Category	Supplemental			GPS Latitude/Longitude		
				Start	End	
Item	DRAFT DWR UCIP LMA Responsibility			39.782777°	39.782777°	
				-121.871179°	-121.871179°	
DWR ID	19291					
Comment Code						
Inspector Comment						
DS_ID:19291 FS_ID:31965 EP_NO: N/A Repair Type: Non-Urgent Crossing Status: Found UCIP Comments: Needs cleaning and clearing the culvert. FIELD_STRUCT_DESC: 24-inch corrugated metal gravity drainage pipe through the levee, 11 feet below the crown. Flap gate on the waterside (WS) end. Concrete U-shaped headwall on each end. Grouted riprap apron on the landside (LS) end. Grouted riprap spillway on the WS end. [Additional Reference(s): DWR Levee Log, 1992. USACE Sacramento O&M Manual 504, May 1965, (HLM 2.22)]. FS Date: 3/7/2014

LS view: U type concrete headwall and CMP on levee slope. Vegetation debris and mud in inlet box.

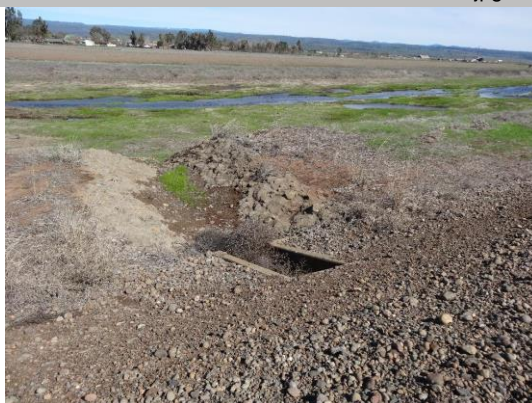
Photo 1 of 3 : UCIP_FA_2019_31966_58401.jpg

LM Start	2.47	Rating **	M	Issue No.	51
LM End	2.47	Issue Type +	Ma	Location *	
Category	Supplemental			GPS Latitude/Longitude	
				Start	End
Item	DRAFT DWR UCIP LMA Responsibility			39.784244 °	39.784244 °
				-121.876810 °	-121.876810 °
DWR ID	19292				
Comment Code					
Inspector Comment					
DS_ID:19292 FS_ID:31966 EP_NO: N/A Repair Type: Non-Urgent Crossing Status: Found UCIP Comments: Needs cleaning and clearing the culvert. FIELD_STRUCT_DESC: 24-inch corrugated metal gravity drainage pipe through the levee, 11 feet below the crown. Flap gate on the waterside (WS) end. Concrete U-shaped headwall on each end. Grouted riprap apron on the landside (LS) end. Grouted riprap spillway on the WS end. [Additional Reference(s): DWR Levee Log, 1992. USACE Sacramento O&M Manual 504, May 1965, (HLM 2.56)]. FS Date: 3/7/2014

WS view: U type concrete headwall and grouted riprap spillway on levee slope.

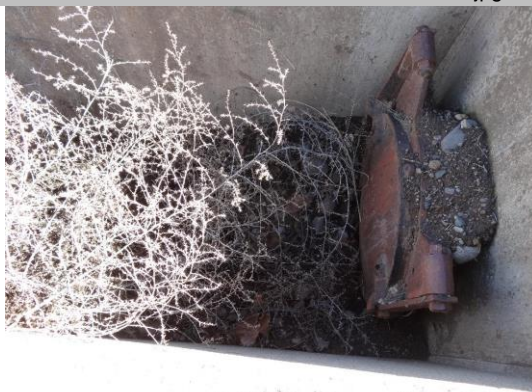
Photo 2 of 3 : UCIP_FA_2019_31966_58400.jpg

WS view: U type concrete headwall and CMP on levee slope. Vegetation debris and mud on outlet box. Needs cleaning and clearing.

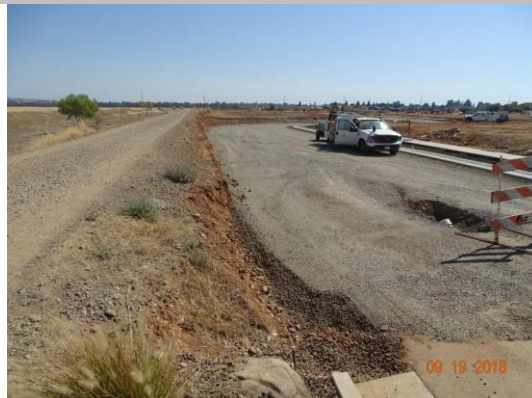
Photo 1 of 2 : FA_2019_NA0003_69_15_20190822_00004.jpg

LM Start	1.56	Rating **	U	Issue No.	15
LM End	1.56	Issue Type +	En	Location *	LS
Category	Earthen Levee			GPS Latitude/Longitude	
				Start	End
Item	Encroachments			39.772190°	39.772190°
				-121.810700°	-121.810700°
DWR ID	DWR_NA0003_05_f_2017_15				
Comment Code					
RW : Retaining Wall					
Inspector Comment					
The developer cut a paved road, gutter and large rocks in slope/toe of the levee. The board is in the process of resolving the encroachment.

View of the housing track road cutting into the levee toe.

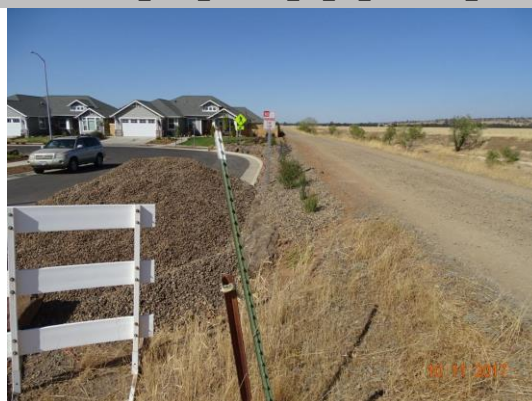
Photo 2 of 2 : FA_2019_NA0003_69_15_20190822_00005.jpg

View of the housing track road cutting into the levees slope and toe.
